**NASA CR-2614**

**EVALUATION OF DISPERSION STRENGTHENED  
NICKEL-BASE ALLOY HEAT SHIELDS FOR  
SPACE SHUTTLE APPLICATION**

**MCDONNELL DOUGLAS ASTRONAUTICS COMPANY**

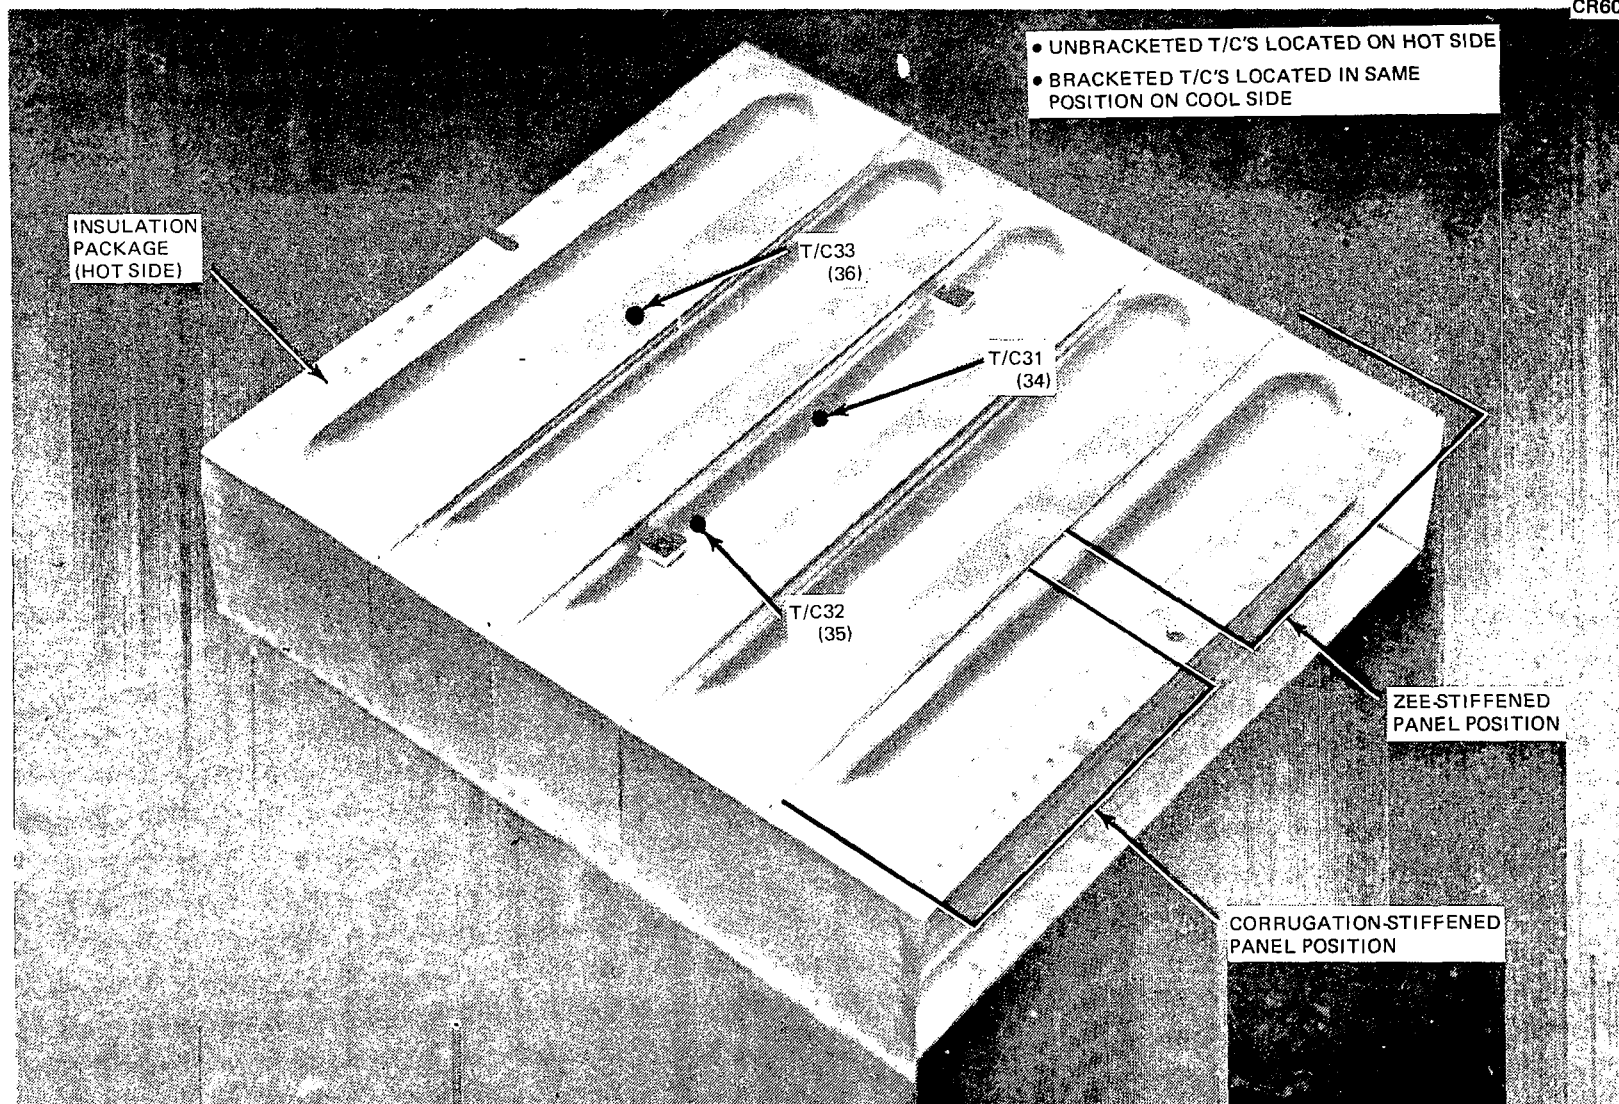
Figure 5-20. Insulation Package Thermocouple Locations

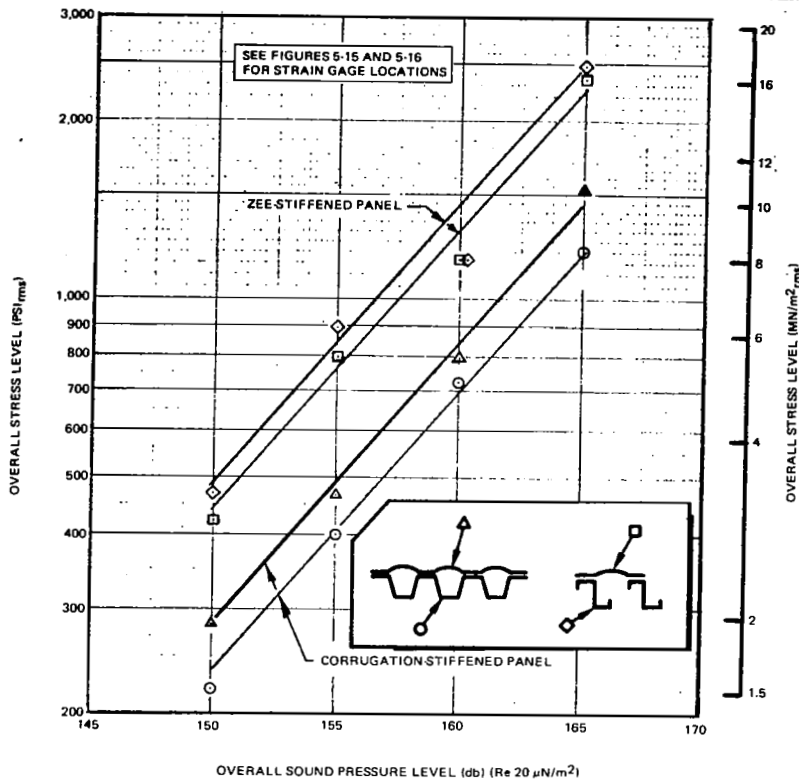
Figure 5-21. RMS Stress as a Function of Overall Sound Pressure Level

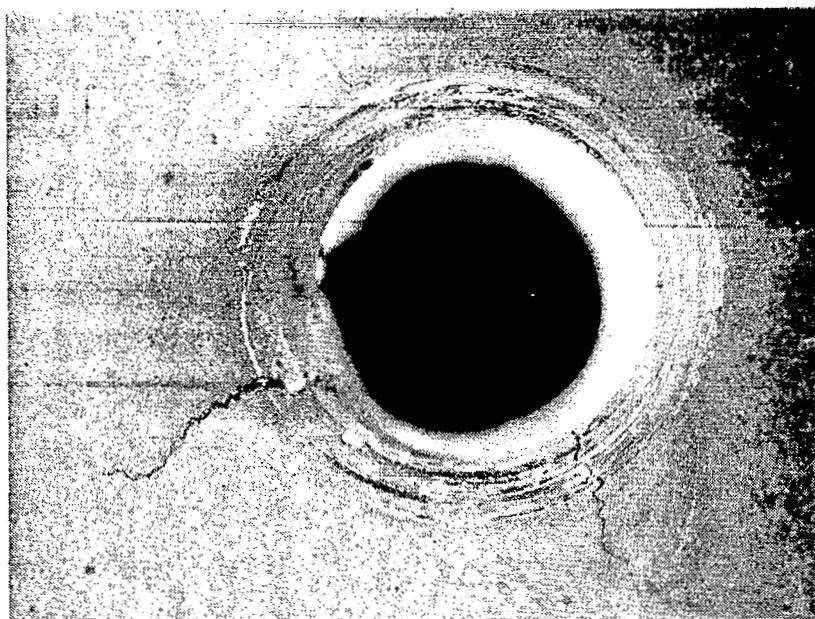
a. ATTACH POINT NO. 1

Figure 5-22 Typical Cracks Observed at End of Twelfth Thermal/Load Cycle

Twelve cycles were applied to the two panels in the initial set of runs using the Space Simulation Chamber. The panels were then removed and given a detailed visual inspection. As a result of this inspection, a number of hairline cracks were detected. A majority of the cracks were observed around the dimpled holes in the panel face sheets, the cracks progressing radially outward from the edges of the holes. Typical cracks observed at the end of the first twelve runs are shown in Figure 5-22. Two other hairline cracks were observed along spotweld rows in the zee-stiffened panel, and a slight buckle was observed in one of the face sheet beads on the zee-stiffened panel. An inspection of the internal insulation package showed no deterioration of that portion of the TPS test components.

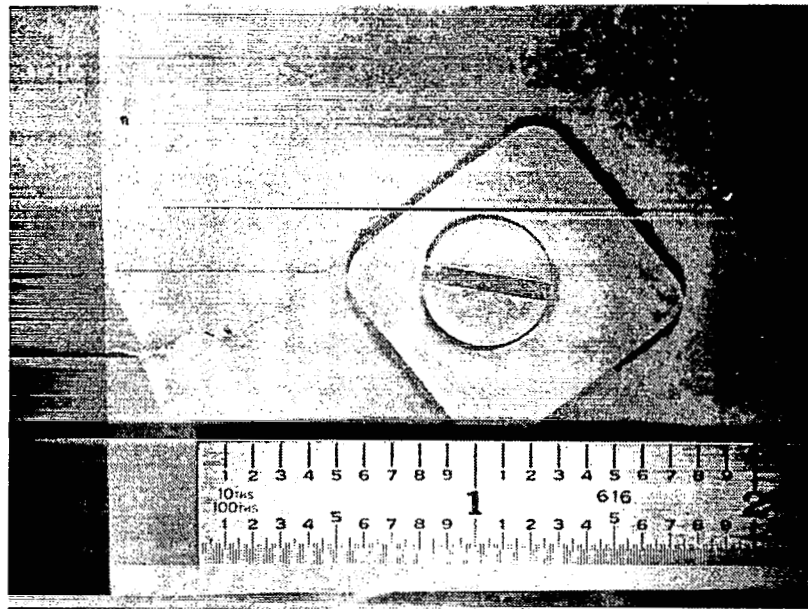
a. ATTACH POINT NO. 1

**Figure 5-24. Panel Face Sheet Cracks After 75th Thermal/Load Cycle**

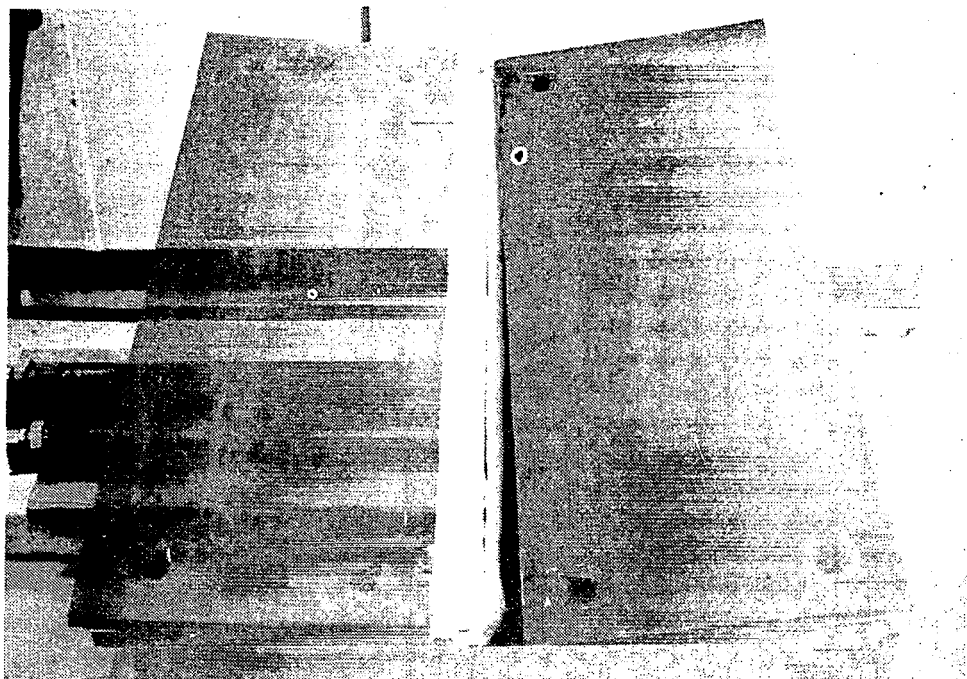
Figure 5-25. Full Scale Subsize Heat Shield After 100 Test Cycles

At the end of the full 100 cycles, a visual inspection was made at the Space Simulation Laboratory before shipment of the components to the Huntington Beach facility. This inspection showed the panels to be in the same condition as noted at the previous inspection after 89 cycles. Posttest photographs of the heat shields and insulation are shown in Figures 5-25 through 5-27 after completion of the full 100 test cycles. Figure 5-25 shows the heat shields after removal of the fasteners and reinforcing washers. The increased cracking and damage at the attach points is evident, particularly at attach point 5 on the zee-stiffened panel. An edge view of the corrugation-stiffened panel is shown in Figure 5-26 while the panels were still attached to the fixture. This view shows the relative overall flatness maintained by the panels even though the 0.0254-cm (0.010-in.) face sheet exhibited a small

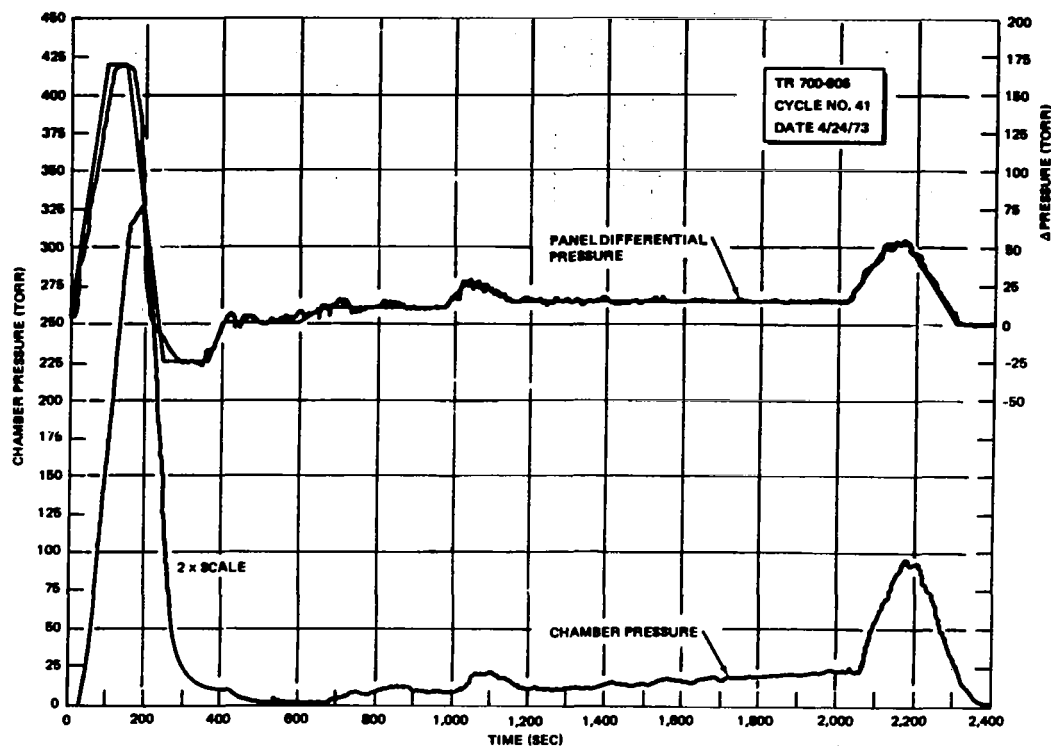
Figure 5-28. Panel Differential Pressure and Chamber Pressure, Run 41

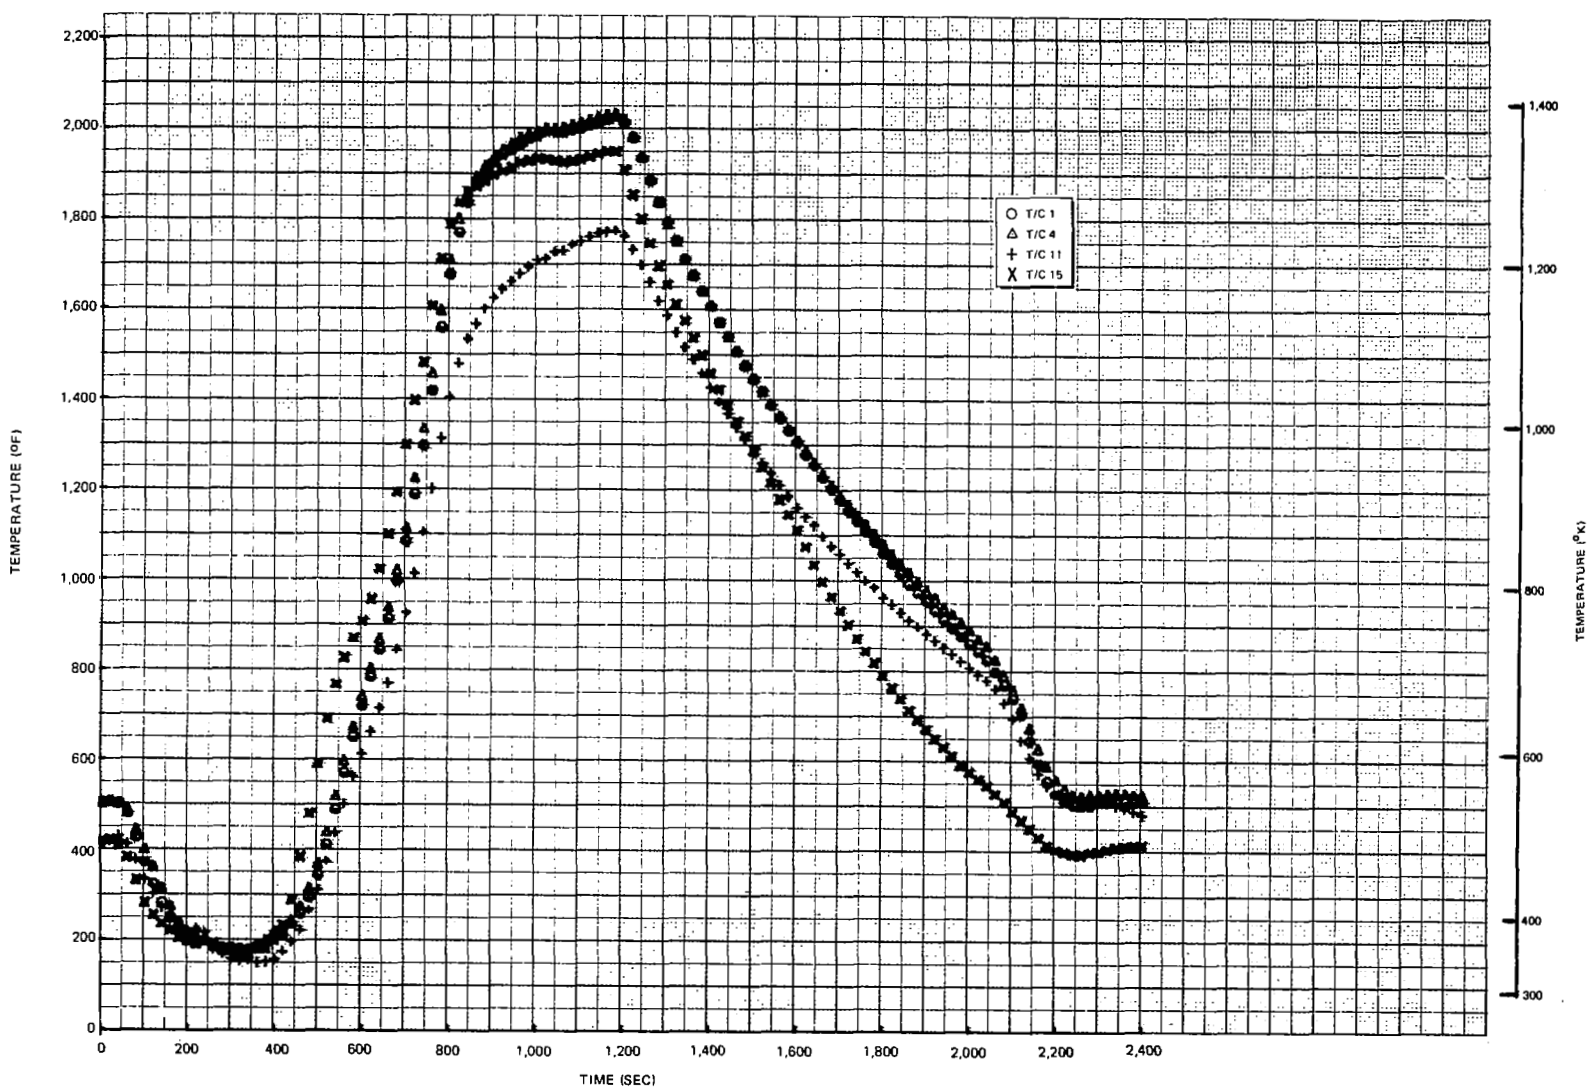
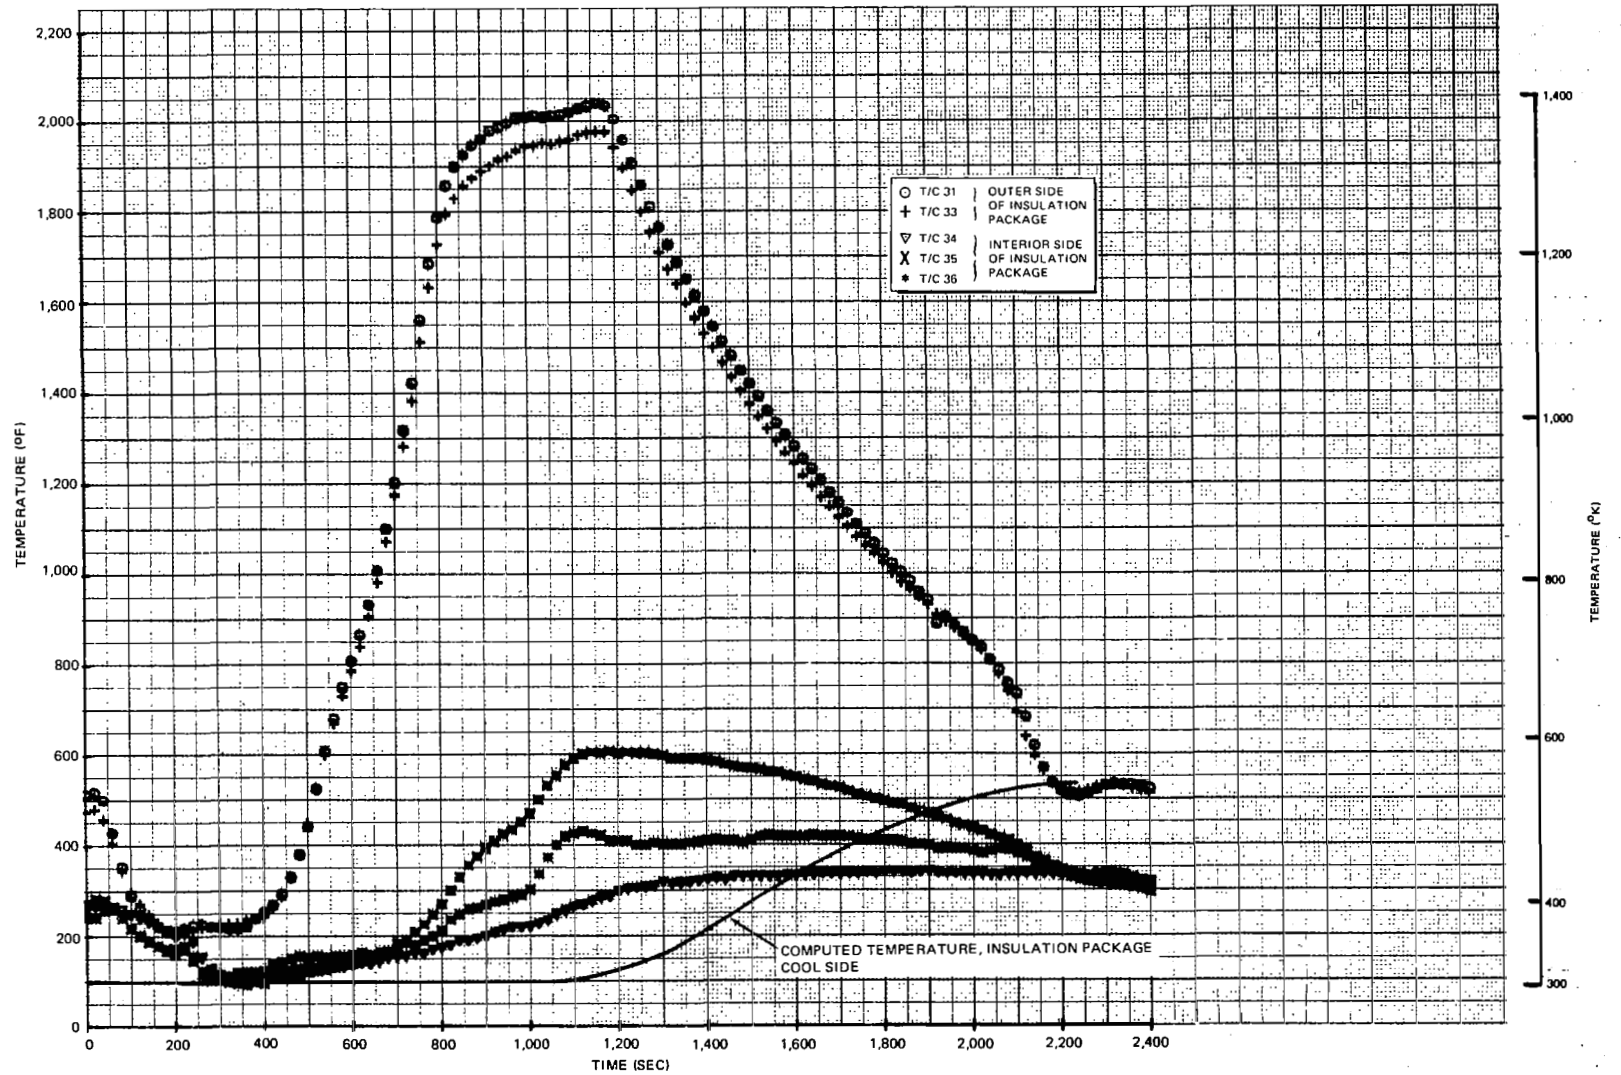
Figure 5-29. Thermocouple Recordings, Run 41 (Page 1 of 2)

Figure 5-29. Thermocouple Recordings, Run 41 (Page 2 of 2)

The insulation package temperatures presented in Figure 5-29 show the lower temperature registered by Thermocouple 34 on the cool side of the package when compared to the temperatures at Thermocouples 35 and 36. The higher temperatures at the latter two positions were judged to have resulted from

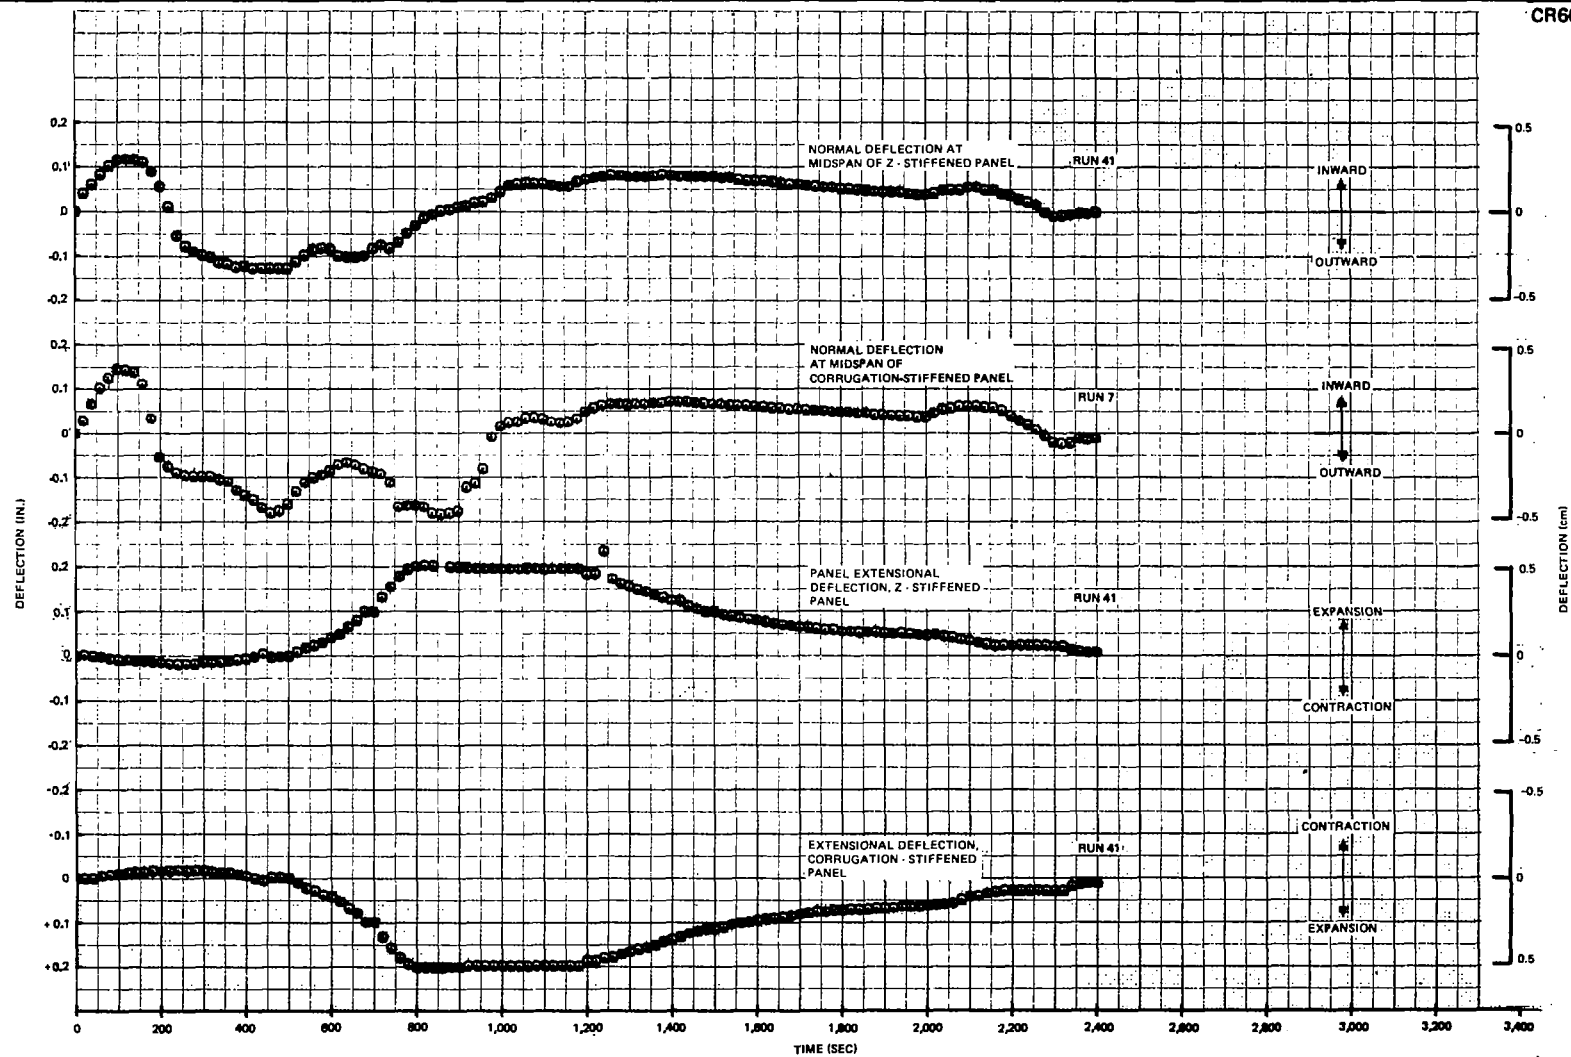
Figure 5-30. Panel Deflections

The deflections, shown in Figure 5-30, indicate maximum normal deflections at panel midspan positions of approximately  $\pm 0.33\text{-cm}$  ( $0.13\text{-in.}$ ). The normal deflection during the simulated entry portion of the test ( $t = 800$  to  $1,600$

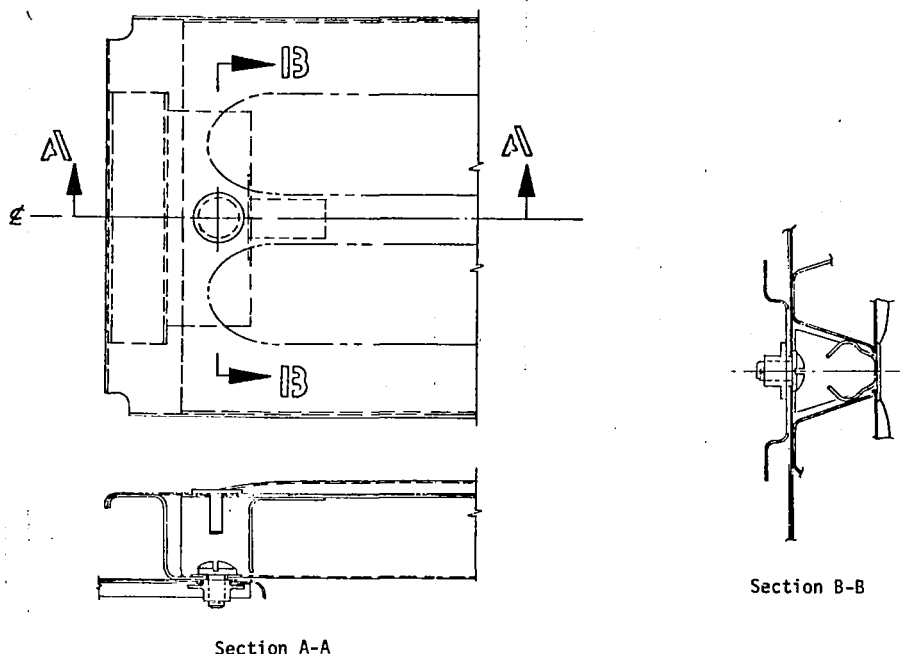
Figure 6-5. Fastening Design for Braze-Reinforced Panel

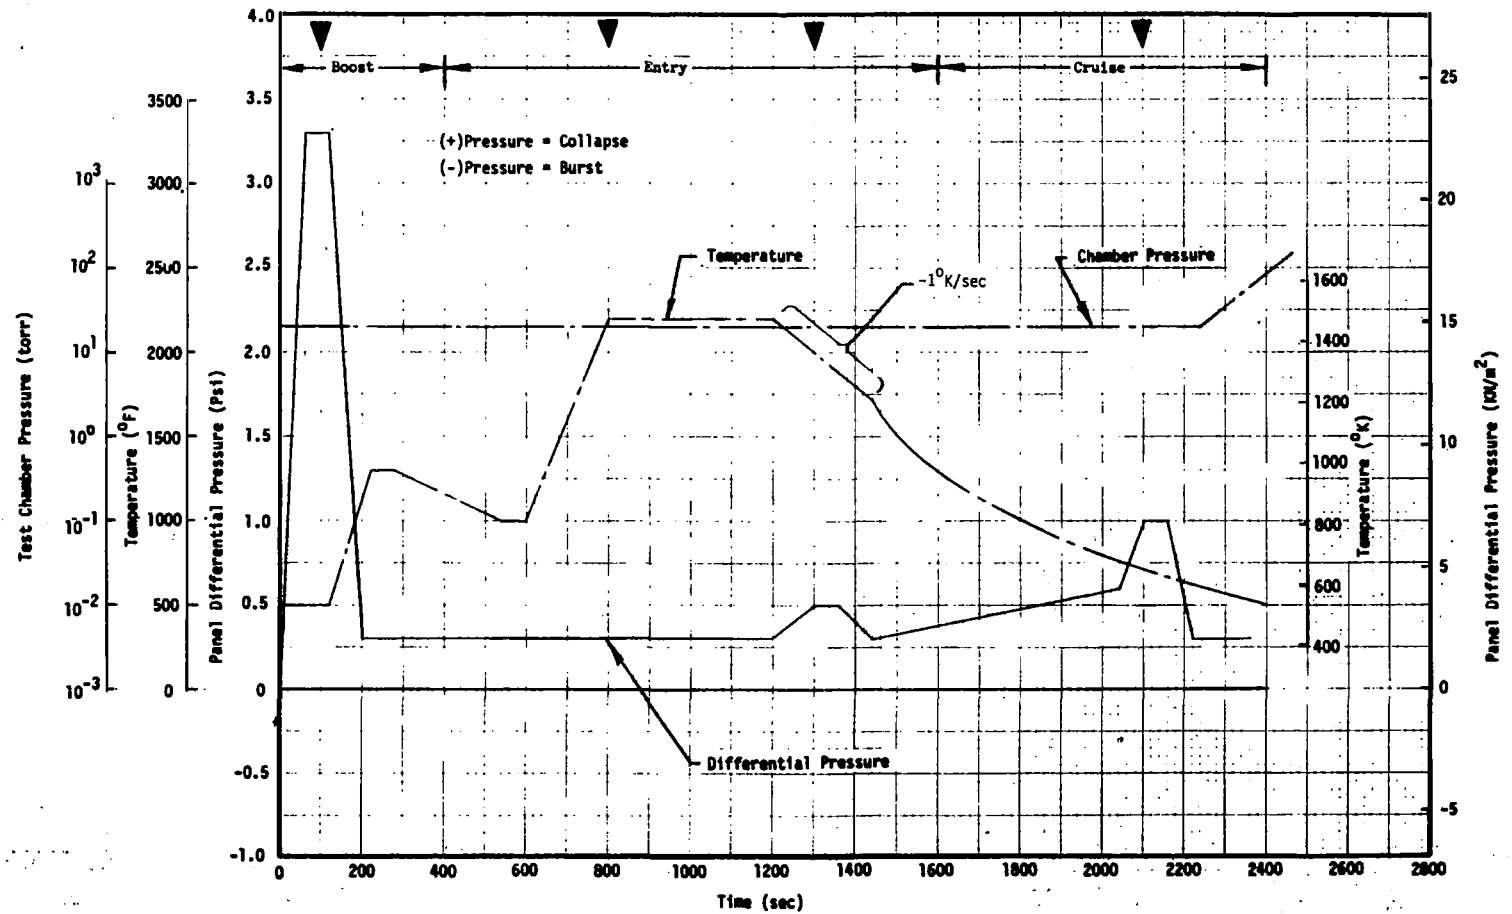
Figure 6-8. Programmed Temperatures and Differential Pressures for Contractor Test Array

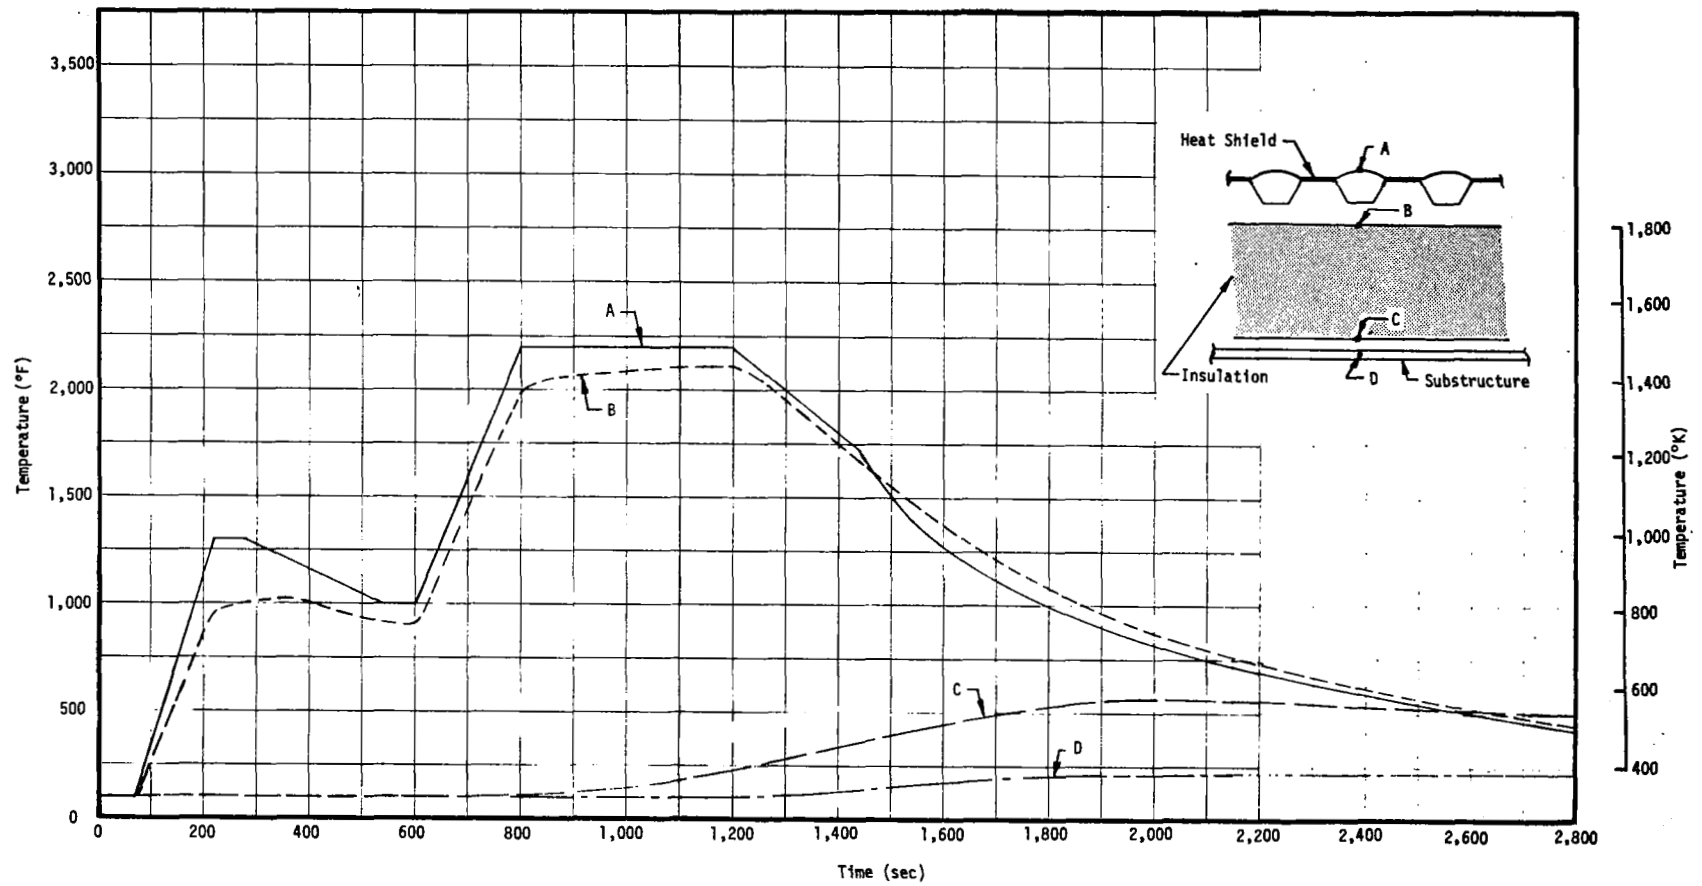
Figure 6-9. Projected Temperature Time-Histories; Contractor Test Array

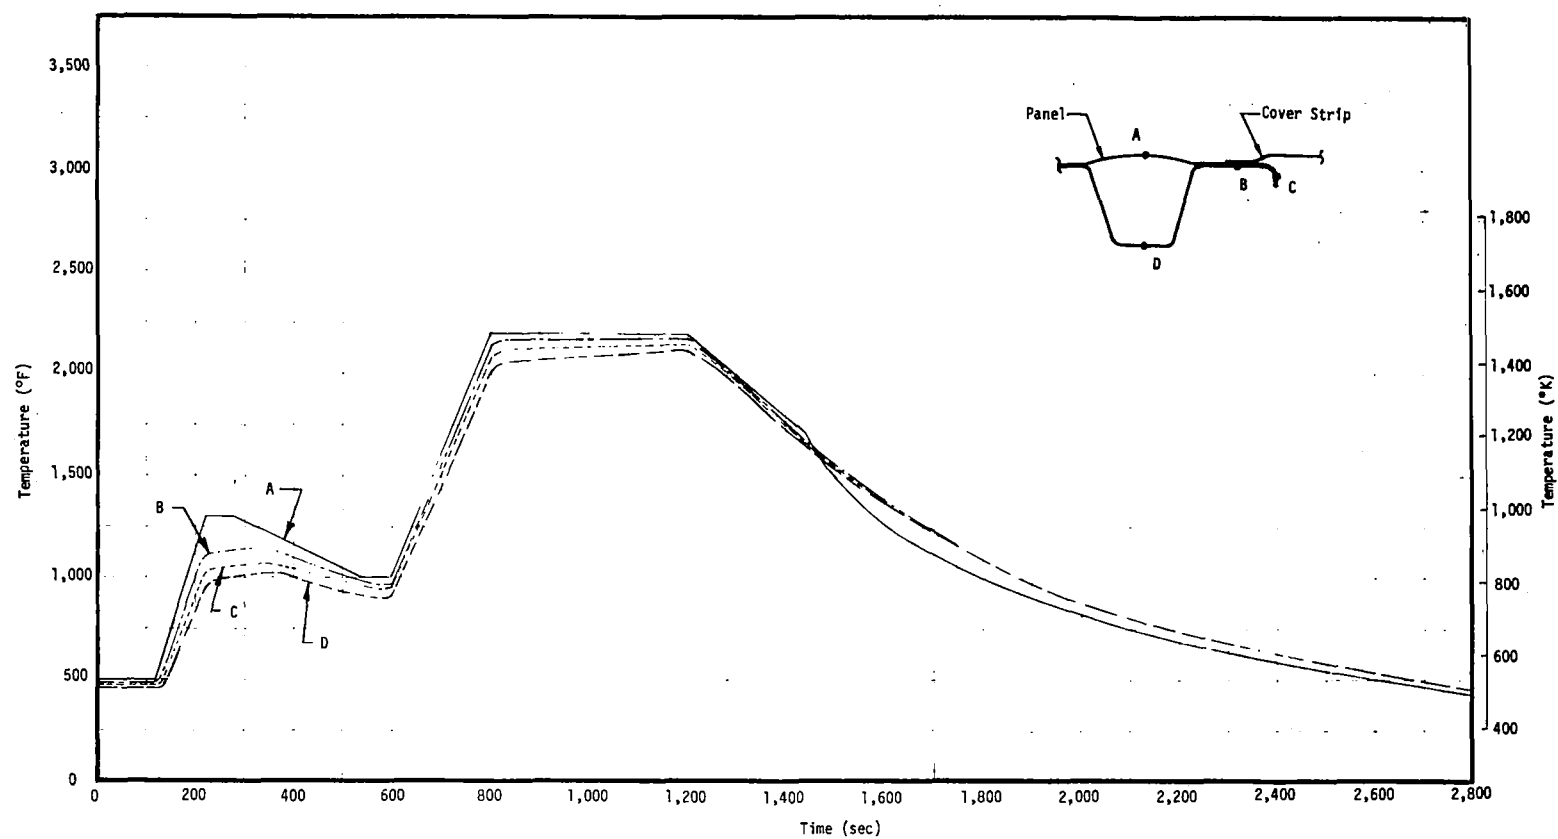
Figure 6-10. Projected Temperature Time-Histories at Panel Edge; Midspan Location

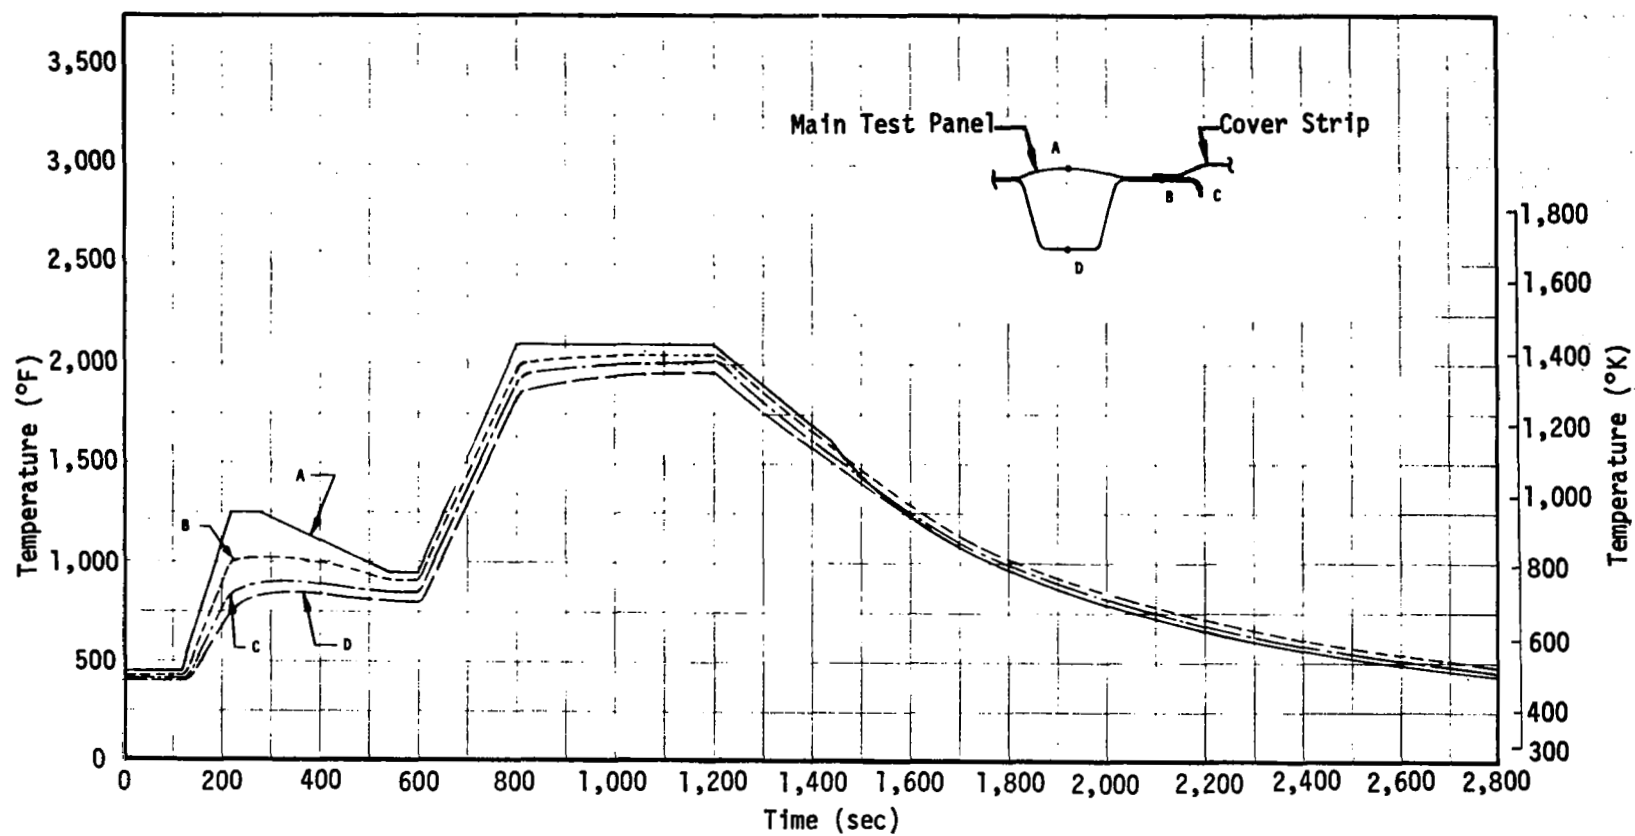
Figure 6-11. Projected Temperature Time-Histories at Panel Edge Near Support Strut

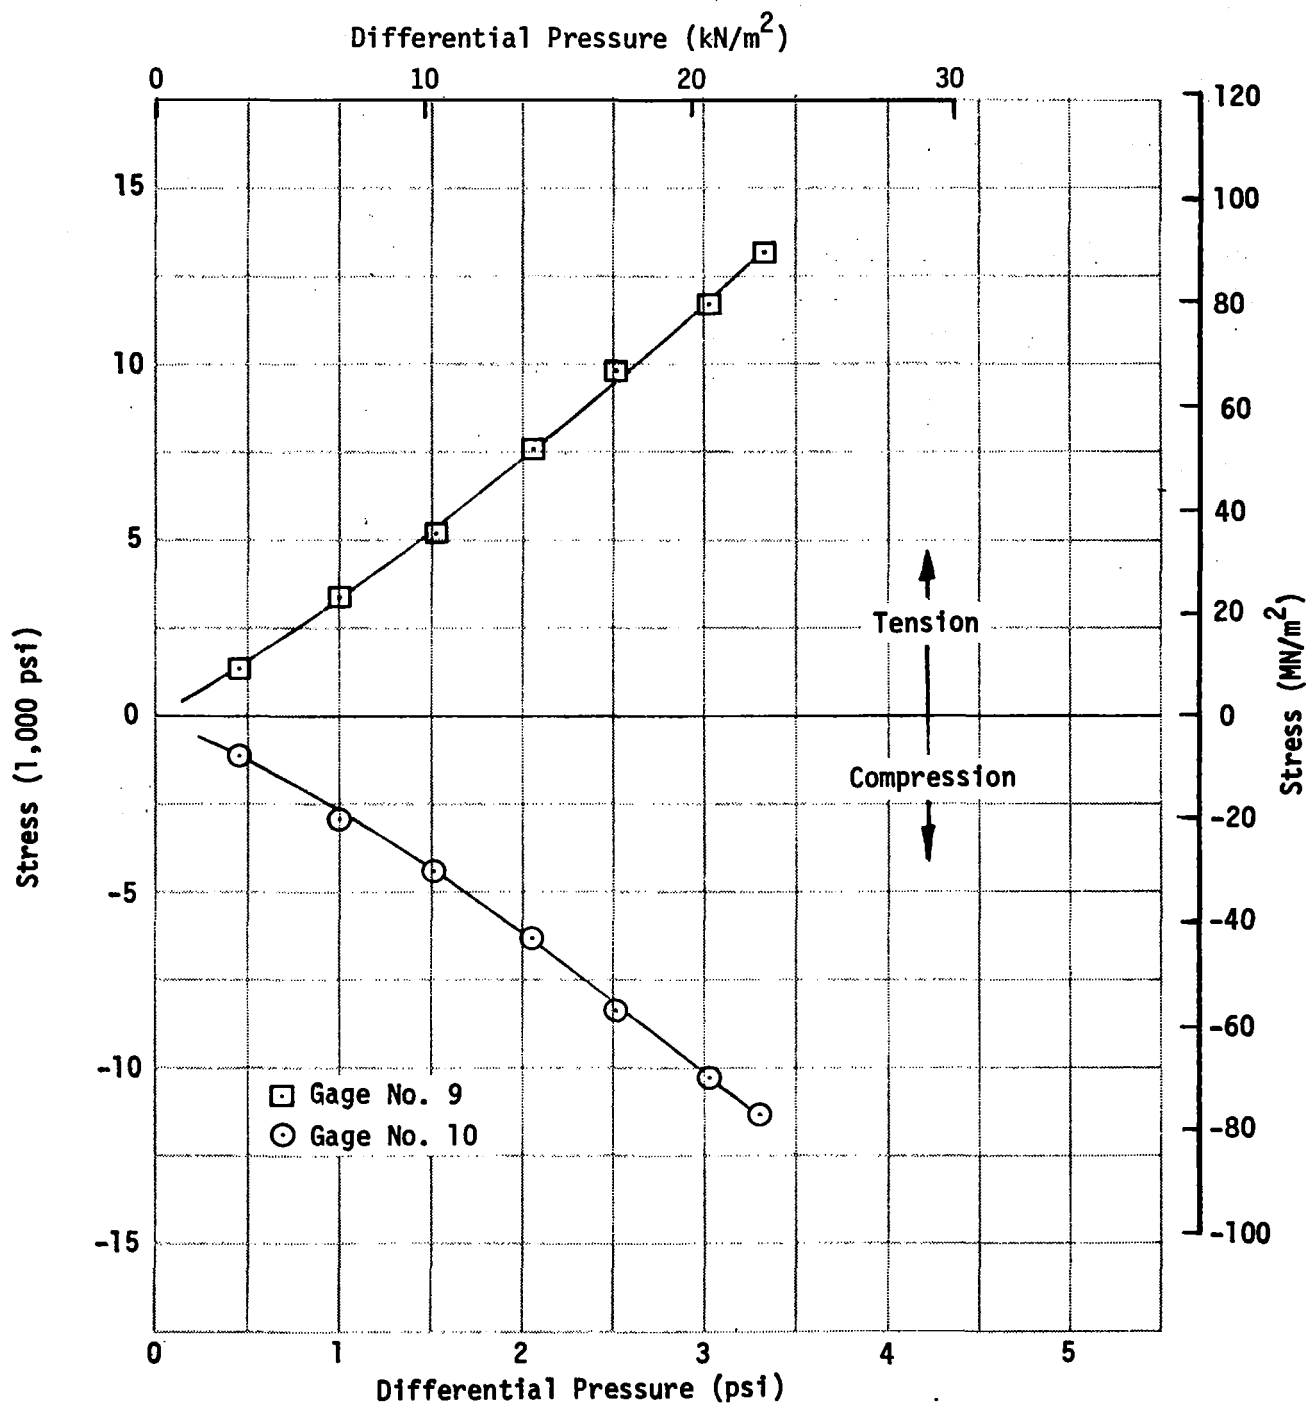
Figure 7-11. Panel Stresses as a Function of Differential Pressure – Gages 9 and 10

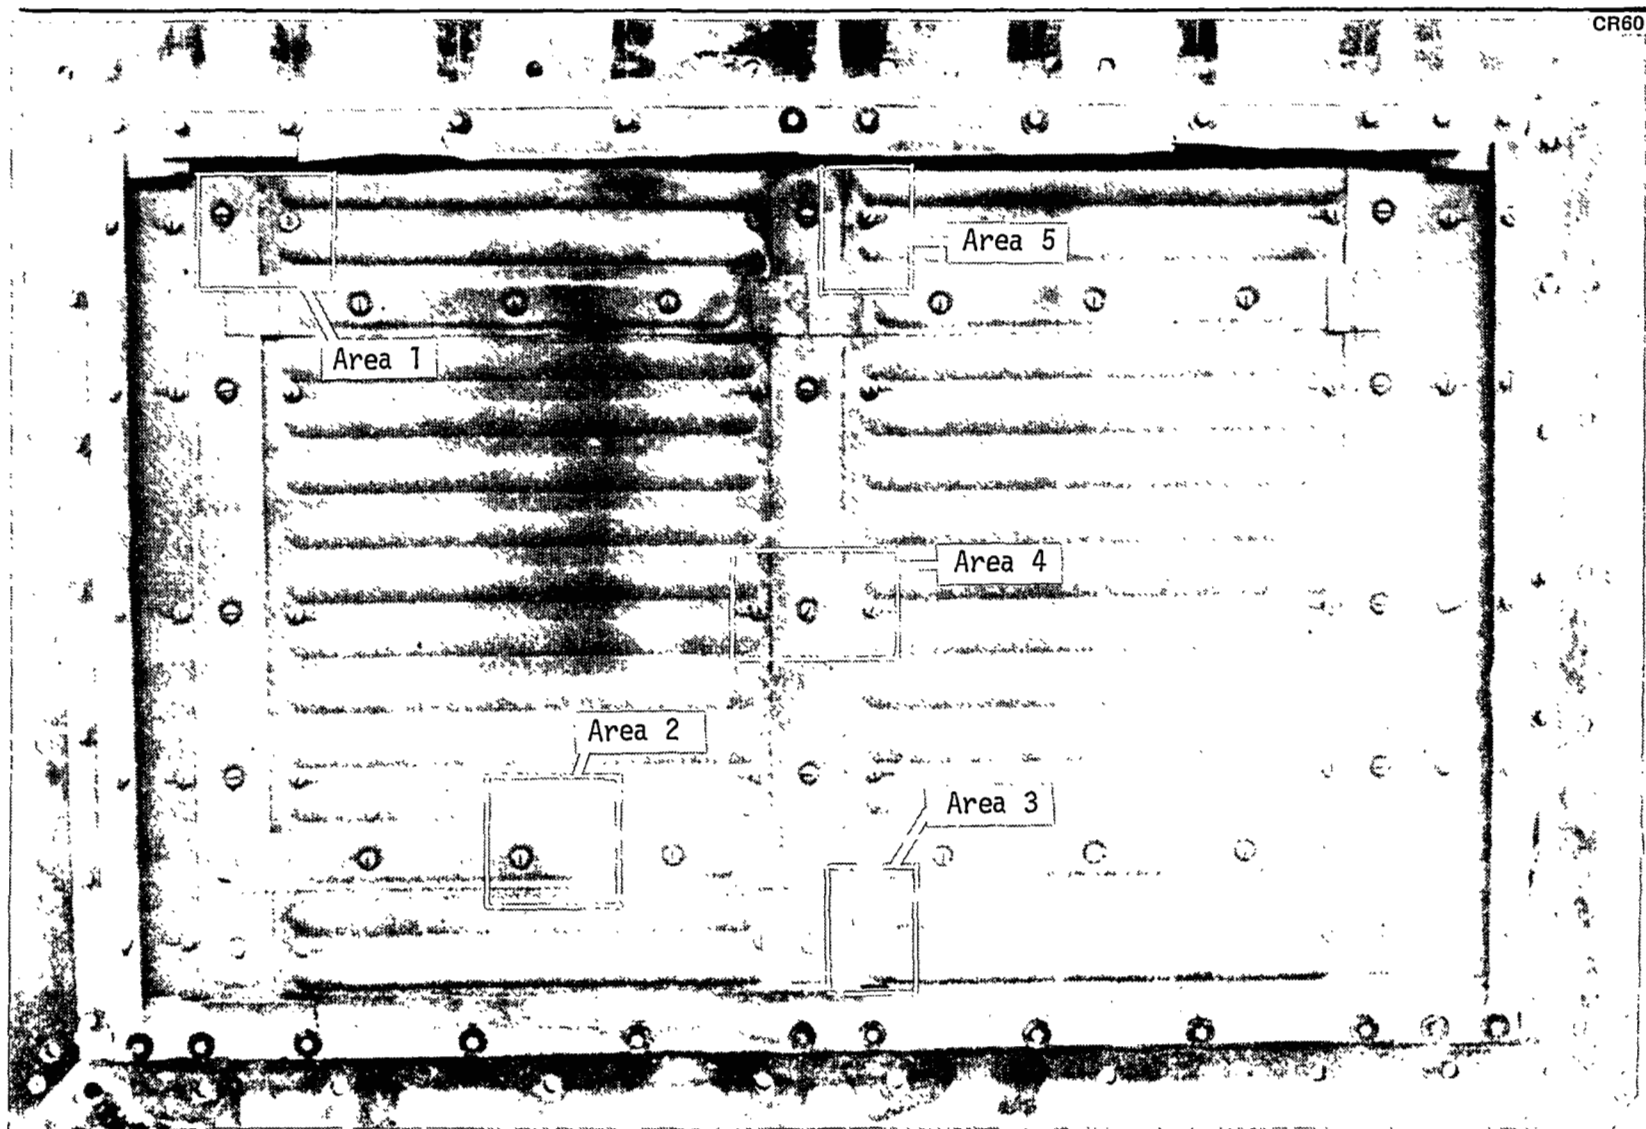
Figure 7-15. Overall View of Test Array After First Mission Test Cycle

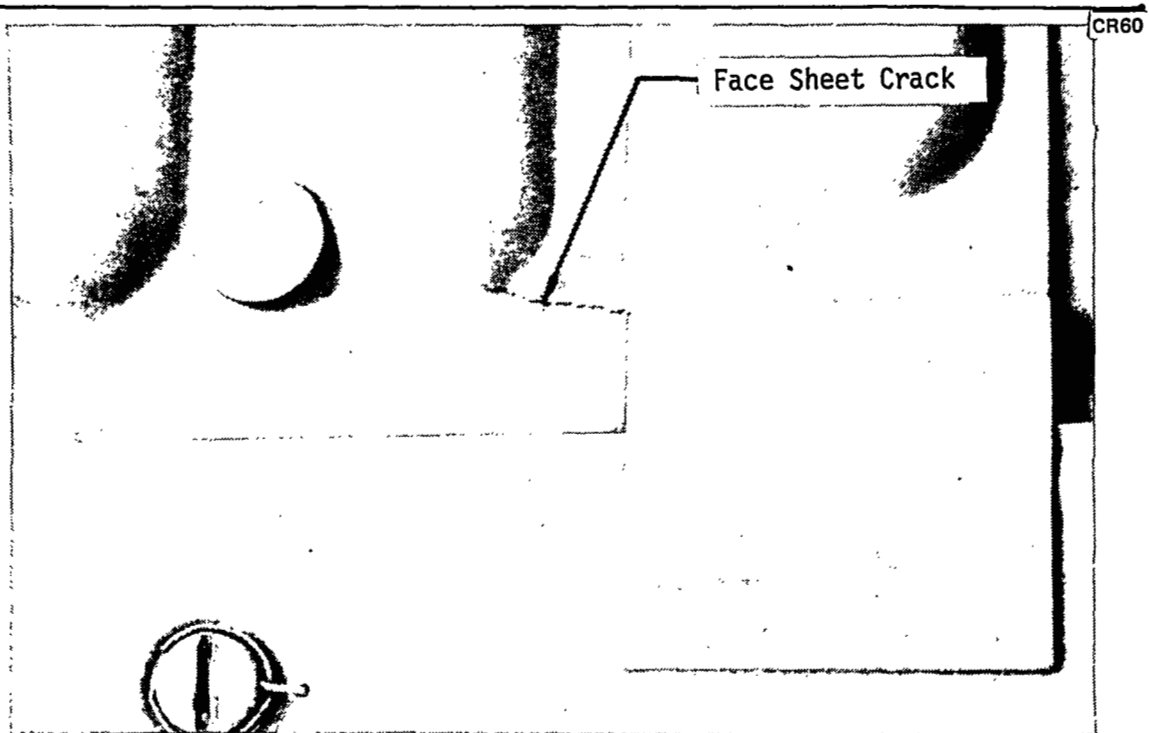
Figure 7-16. Damage in Braze-Reinforced Panel After First Mission Test Cycle

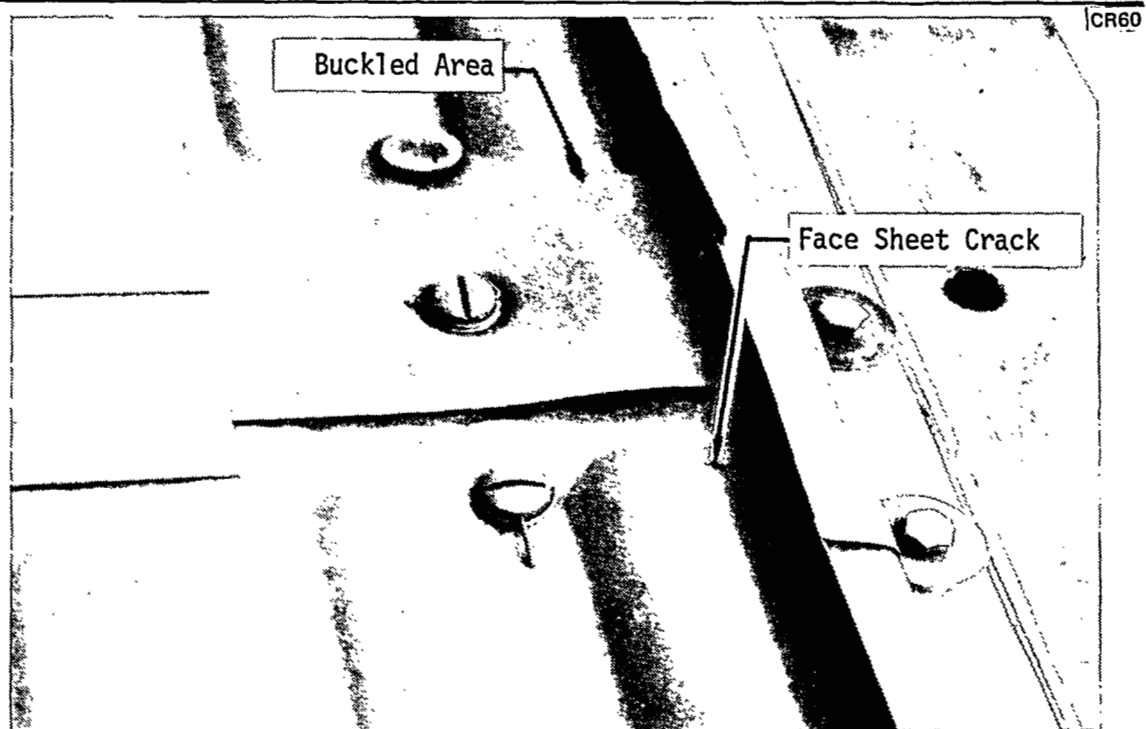
Figure 7-17. Close-up View of Center Transverse Cover Strip (Area 5)
